**DEPARTMENT OF THE AIR FORCE  
DETACHMENT 3, USAF SCHOOL OF AEROSPACE MEDICINE (AFMC)  
KADENA AIR BASE JAPAN**

SUBJECT: Consultative Letter, AFRL-SA-BR-CL-2009-0076, Pest Management Program Review for Elmendorf Air Force Base, Alaska.

**1. Executive Summary:** A thorough review of all operational aspects of the Elmendorf AFB Pest Management Program was conducted the week of 10 August 2009 as requested by HQ PACAF/A7AN. The staff assistance visit (SAV) was conducted by the Medical Entomologist from Detachment 3, USAF School of Aerospace Medicine (Det 3, USAFSAM) and the Chief Entomologist from the Air Force Aerial Spray Flight (USAF Reserve Command, Youngstown, OH). This SAV was done concurrently with a mosquito survey project done in conjunction with the Public Health Flight (3 AMDS/SGPM). The purpose of this particular SAV was to address the needs of the Elmendorf AFB Pest Management Shop (3 CES/CEIOUB) and to ensure compliance of all DoD, AF, Federal and State regulations. Overall, the Pest Management Shop is a well-run program in spite of the long-term problematic issues with the current and collocated design of the pest management facility. These problems (i.e., compliance

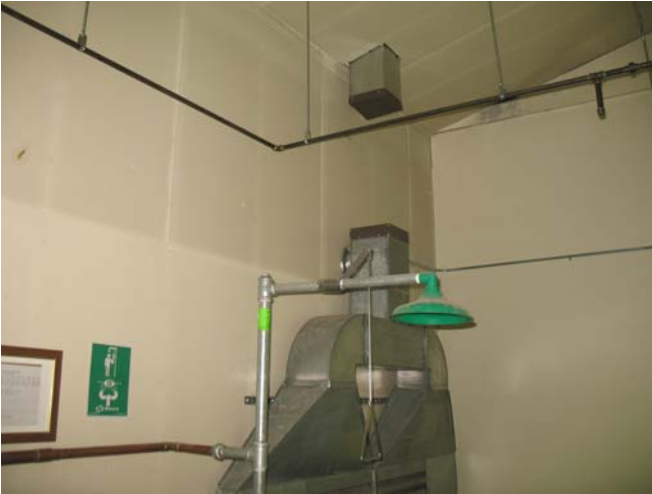
**b.** The ventilation system for pesticide mixing is not designed in accordance with DoD guidelines (PM 45.13.AF, implementing para 3.5.4.2 of TG 17). The system must be roof-mounted with a vertical discharge of airflow. The current set-up, which was originally designed for roof-mounted vertical discharge (see Attachment 1, Figure 1), has now been configured to discharge from the side wall of the mixing room. The airflow then discharges in a downward direction into the recreation courtyard located behind the pest management facility – a less than ideal situation. This discrepancy must be re-configured to meet DoD guidelines and still meet the necessary minimum of six air changes per hour.

Fig 1. Elmendorf AFB: Improper ventilation

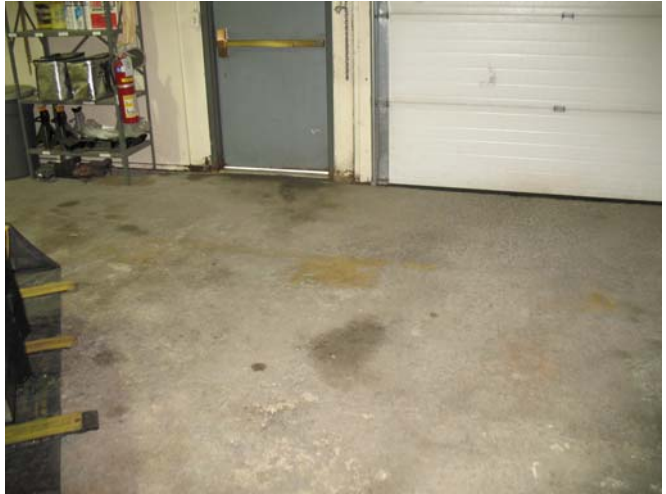
**c.** There is no permanent mechanism to ensure that a spill is contained within the vehicle and application equipment storage area (i.e., the garage) from going outside or to prevent rainwater from coming into the garage. The requirement (from PM.45.9.AF) is to have either a sloped garage or a berm (e.g., a 4-inch curb) IAW TG 17 para 3.1.5.1. This curb can be constructed on the floor immediately upon entering the doors of the garage (see Attachment 1, Figures 2-3).

**d.** Concrete floors must have a nonabsorbent, nonskid finish IAW TG 17 3.1.5.1 (see Attachment 1, Figures 2-4). This is to prevent pesticides from seeping into the concrete or running down into the cracks that are currently found in the garage area. A proper sealant must be applied in the garage where the pesticide application equipment is stored.

Fig 2. Elmendorf AFB: No berm/improper grading

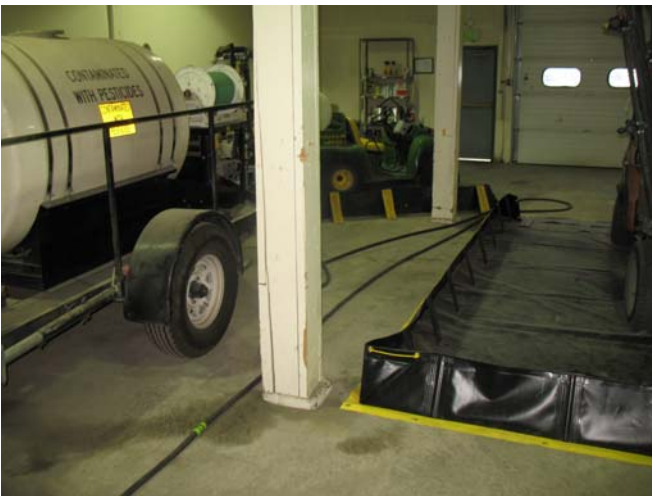
Fig 3. Elmendorf AFB: No berm/improper grading

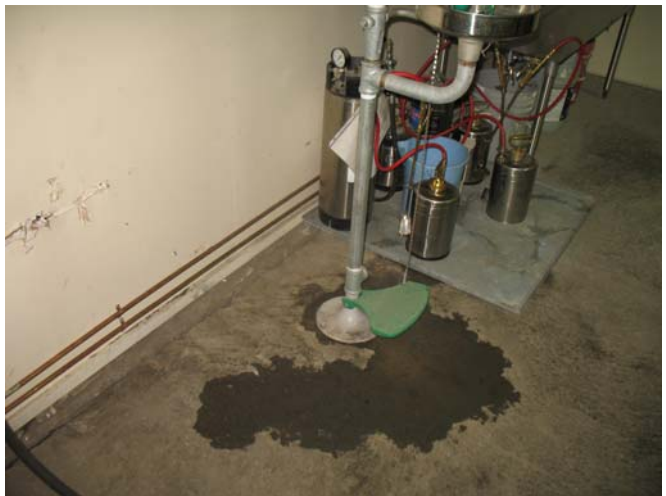
Fig 4. Elmendorf AFB: Inadequate floor sealant

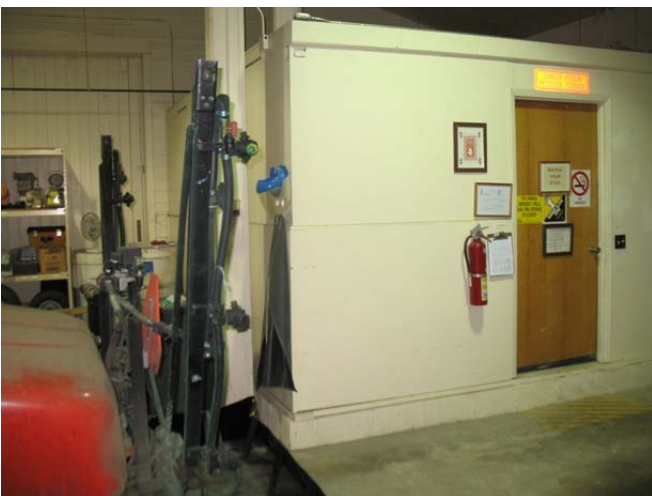
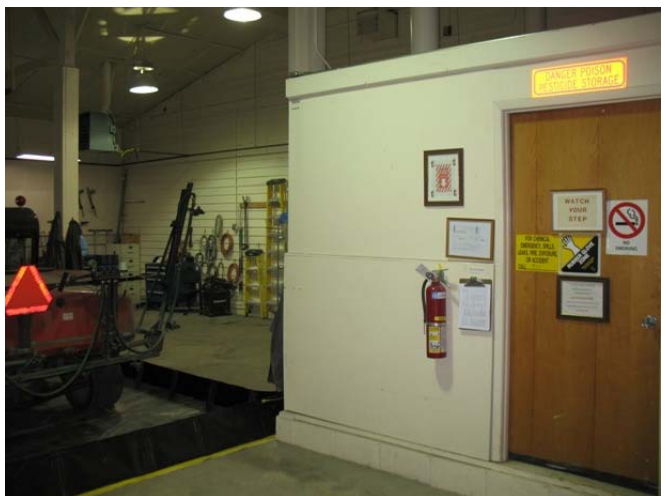
**e.** There is not adequate fire protection, as directed by the DoD (PM 45.20.AF, implementing para 3.1.4.1.3 of TG 17), that exists between where the vehicles stored in the garage and where the pesticides are stored. By regulation, when vehicles are located under the same roof as the pesticide area, they must be separated from the pesticide area by a minimum of 2-hour fire rated construction. Currently the pesticides are separated only by sheet rock (see Attachment 1, Figures 5-6).

Figs 5 and 6. Elmendorf AFB: Motorized vehicles next to non-flame resistant pesticide storage area
